Sedimentation Patterns in a Stabilized Migratory Inlet, Blind Pass, Florida

Wang, P., Tidwell, D. K., Beck, T. M., and Kraus, N. C. 2007. Sedimentation Patterns in a Stabilized Migratory Inlet, Blind Pass, FL. *Proceedings Coastal Sediments '07 Conference*, ASCE Press, Reston, VA, 1377-1390.

SEDIMENTATION PATTERNS IN A STABILIZED MIGRATORY INLET, BLIND PASS, FLORIDA

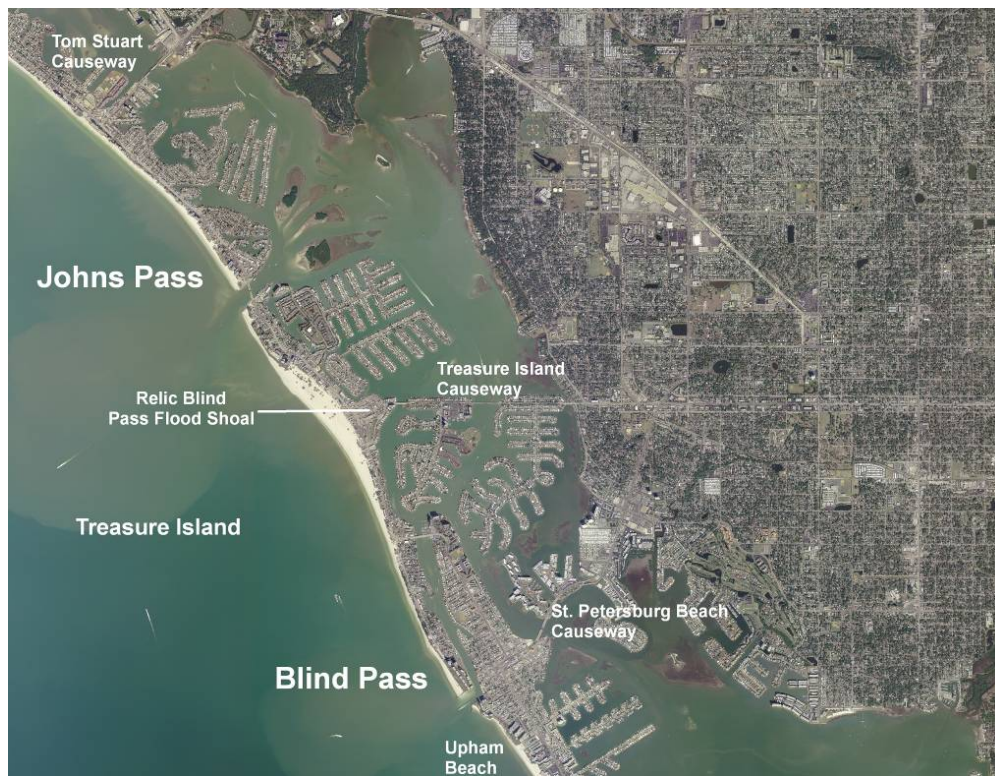
Fig. 1. Blind Pass and Johns Pass to the north.

Blind Pass and the adjacent Johns Pass service a portion of Boca Ciega Bay along the west-central Florida coast (Fig. 1). The entire area, from the beach to the inlets to the back-bay, is heavily developed. The origin of Blind Pass is not clear. Before the opening of Johns Pass by a hurricane in 1848, Blind Pass was a major inlet along this stretch of the coast with large flood and ebb shoals. As Johns Pass captured a substantial portion of the tidal prism, Blind Pass became a wave-dominated inlet and started rapid southward migration. It was eventually stabilized with a series of hard structures. Following the stabilization, chronic shoaling of the channel and subsequent dredging occurred, along with a persistent erosion problem at the downdrift Upham Beach.

Before 1848, Blind Pass was a fairly large inlet and was located directly gulfward of its flood shoal (Fig. 1). The opening of Johns Pass that year started a substantial trend of decreasing tidal prism at Blind Pass. As a result, the inlet began to migrate rapidly to the south so that, by 1926, the inlet had migrated more than 2 km. The year 1937 marks the beginning of direct stabilization with initial dredging and construction of the south jetty and seawall. Continued sediment shoaling in the inlet entrance channel led to extension of south jetty in 1951 and construction of the north jetty in 1962. Also, between 1940s and 1960s, extensive dredge-and-fill construction was conducted in Boca Ciega Bay (Fig. 1). The artificially created land, as well as construction of several causeways, resulted in significant reduction of back-bay area, and thus a further decrease in tidal prism. The south jetty was extended in 1975, and a weir with a 12-m gap was added in 1986. The weir was closed in 2004. The north jetty was extended in 1976 and 1983. These structures along with the significantly decreased tidal prism have made Blind Pass channel a trap of the southward longshore transport allowing little to no bypassing. In order to maintain the channel, the inlet was dredged in 1937, 1964, 1969, 1975, 1979, 1983, 1990, and 2000.

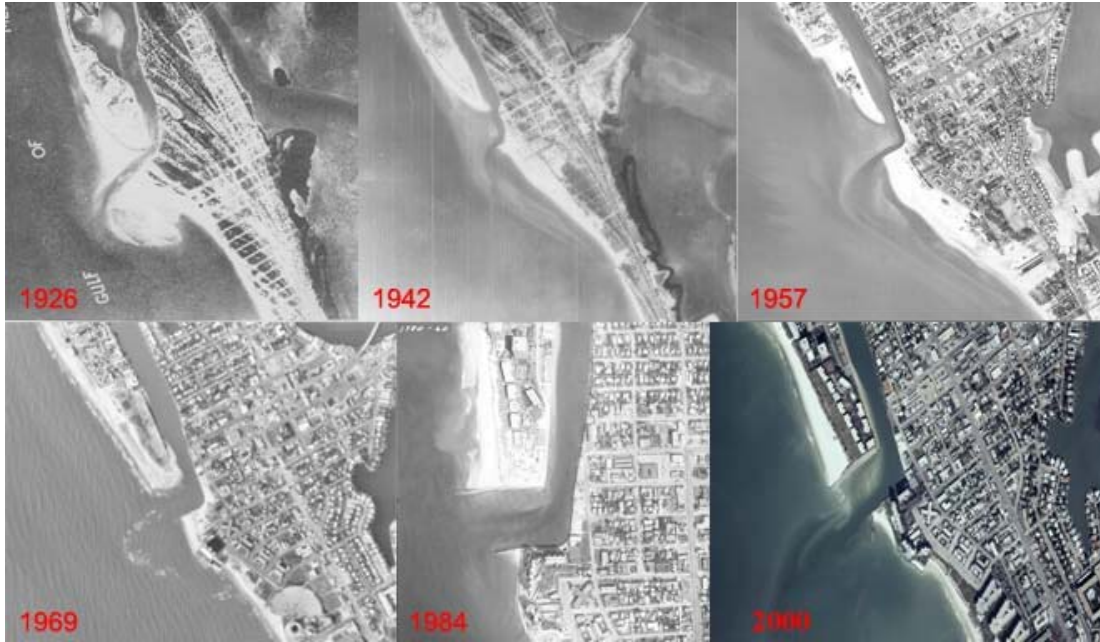
Fig. 2. Time-series aerial photos of Blind Pass.

Artificial interferences on the morphodynamics of Blind Pass are illustrated well by time-series aerial photographs (Fig. 2). Blind Pass is characterized by a nearly 90-deg. turn before entering the Gulf of Mexico. We focus on the entrance channel at and gulfward of the turn. In 1926 (Fig. 2A), the inlet was still in pristine condition. A large ebb shoal and southward sand bypassing are apparent. By 1942 (Fig. 2B), the south side had been stabilized. The ebb delta and southward bypassing are still visible, but to a reduced degree. Beach erosion at Treasure Island to the north becomes obvious. By 1957 (Fig. 2C), the ebb shoal and southward bypassing are still visible. At the same time, erosion at the updrift Treasure Island had become severe. By 1969 (Fig. 2D), both sides of the inlet were stabilized. The ebb shoal and southward bypassing diminished substantially. Through a combination of jetty, groin field, and beach nourishment, erosion at the updrift Treasure Island was mitigated. However, severe erosion at downdrift Upham Beach to the south developed. Shoaling of the inlet channel and severe erosion downdrift are the main features of the 1984 photo (Fig. 2E), which was taken a year after the 1983 dredging. The ebb shoal and southward bypassing become indistinguishable. This trend continued and is shown in the 2000 photograph (Fig. 2F) just before the last dredging to date. The present study on shoaling in the channel was commenced after the 2000 dredging.

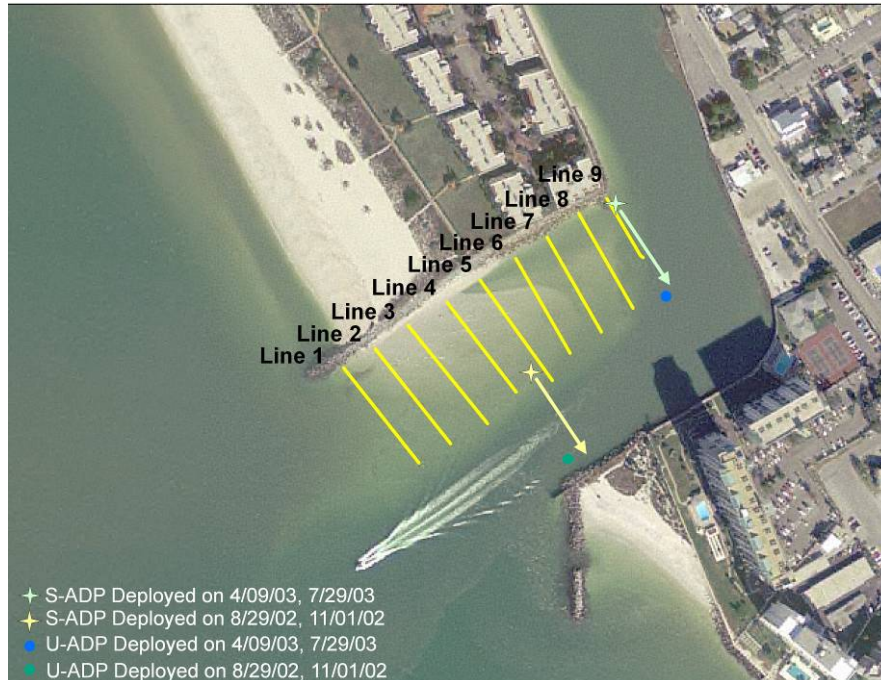
Fig. 3. The north shoal profiles and locations and times of current meter deployments.

The present study examines sediment shoaling in the Blind Pass entrance channel via a series of field investigations, through which a numerical model of circulation was established. Time-series bathymetric surveys were conducted, as well as flow measurements. Bathymetric surveys were conducted roughly quarterly from August 2002 to June 2004. The surveys were conducted with a combination of precision echo sounder for depth and a synchronized Real-Time-Kinematic (RTK) Global Positioning System (GPS) for position. Water level variations were measured to cross-check the tidal influence on the floating platform survey. During the study, the northern side of the inlet became too shallow to survey by boat. Level-and-transit surveys using an electronic total station were conducted there monthly from February 2003 to February 2004. The monthly survey of 9 lines over the northern shoal, extending to roughly 1.5 m water depth, was designed to capture the infilling rate and pattern over this active shoaling area (Fig. 3). Surveys are referenced to NGVD29, which is roughly 0.15 m below mean sea level in this area.

Sedimentation on the north shoal was monitored through monthly surveys of nine lines (Fig. 3). Four areas with different patterns of accumulation and erosion in the shoal can be distinguished as the: mouth area (lines 1 and 2), middle area 1 (lines 3 and 4), middle area 2 (lines 5 and 6), and the inner area (lines 7 through 9). From February to August, or the summer of 2003, a considerable amount of scour occurred in the mouth area (Fig. 11A). Little change was observed during the next two months. A tremendous amount of shoaling occurred in the mouth area between October and December of 2003, or at the beginning of the winter season. Scour was measured during the late winter between December 2003 and February 2004. Further into the inlet in middle area 1, little change occurred during the summer (Fig. 11B). A large amount of shoaling occurred at the beginning of winter, followed by further accumulation during late winter. Even further into the inlet at middle area 2, little change was observed during most of 2003 (Fig. 11C). A tremendous amount of shoaling occurred in the late winter. Near the bend of the inlet at line 9, southward progradation of the shoal occurred throughout the year (Fig. 11D). A large amount of shoaling was also observed during late winter.

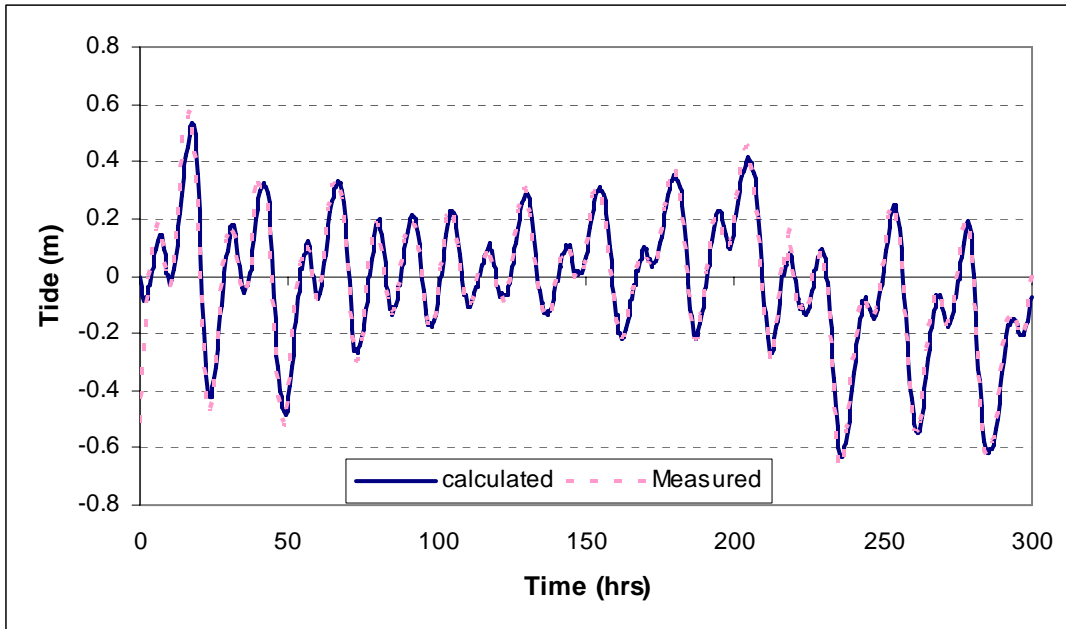
Fig. 4. Measured and calculated tidal water level at Blind Pass, January 12 to 25, 2001.

The tide in the study area is mixed diurnal and semi-diurnal. Spring tides, with a range approaching 1 m, tend to be diurnal. A secondary cycle of typically less than 20 cm in range usually occurs on the rising phase of spring tide (Fig. 4). Neap tides ranging to about 0.5 m are mostly semi-diurnal. Therefore, although spring tide has greater overall range, the rate of water level change during the rising phase is not greater than the semi-diurnal neap tide; however, the rate of the falling phase is greater.

Given the uniform vertical flow profile and substantial horizontal variation, a depth-averaged circulation model, such as the CMS-M2D, is a suitable and valuable tool to examine the Blind Pass hydrodynamics. The 2-week model run, spanning a spring and neap tide cycle, reproduced the measured water level well (Fig. 4). Measured velocity was also reproduced well, especially during flood (Fig. 5). The under-predicted peak ebb velocity may be related to the fact that a point measurement is compared to an averaged velocity over a 15x15 m grid. The substantial spatial (horizontal) variation of the ebb flow and the exact location of the flow meter may cause a slight inconsistency. Overall, results from the CMS-M2D represented the observations well over the 2-week period.

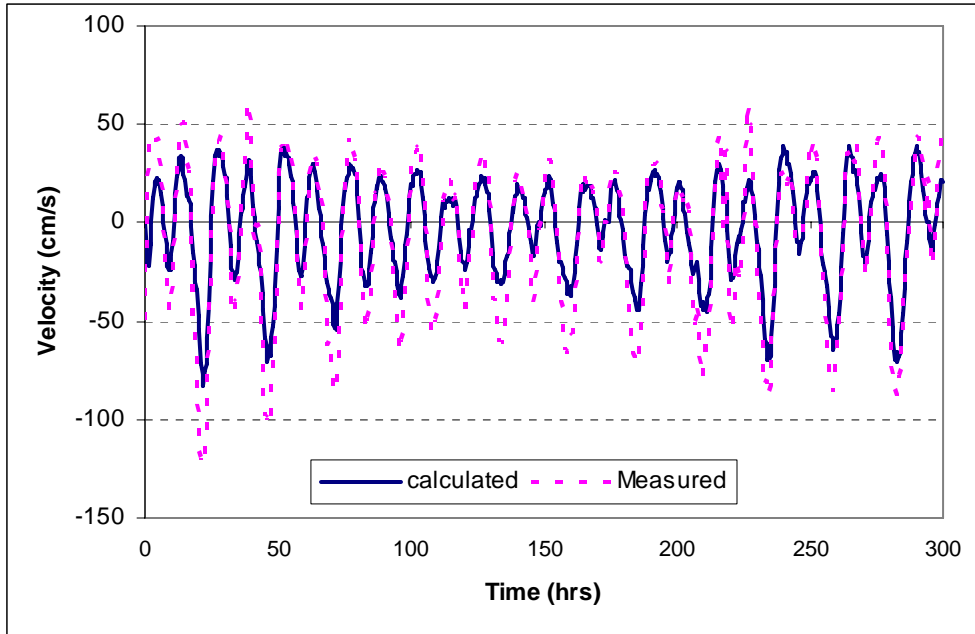
Fig. 5. Measured and calculated tidal flow velocity, January 12 to 25, 2001.

The measured flow velocity through Blind Pass exhibits the aforementioned tidal water-level characteristics (Fig. 5). The peak flood velocity is fairly uniform through time, with the weaker velocity appearing during the transition from the semi-diurnal neap to the diurnal spring tide. The peak ebb velocity shows large variation. The peak ebb velocity during spring tide is almost twice the magnitude of the peak flood velocity during neap tide in the channel thalweg. As discussed in the following, spatial variation patterns of flood and ebb currents across the channel also influence the peak magnitude.

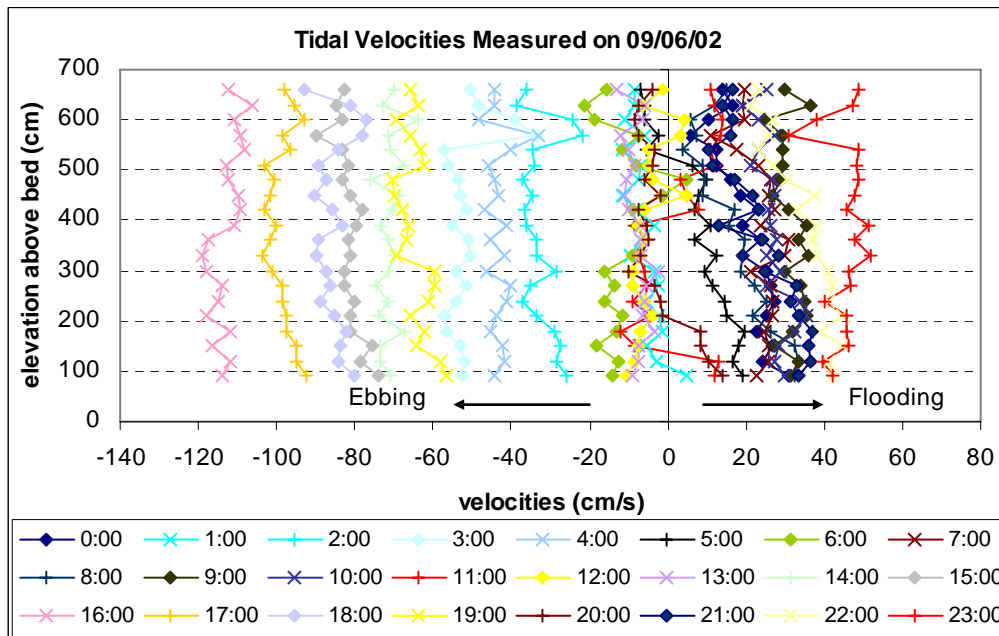
Fig. 6. Typical vertical profiles of current during spring tide.

Vertical velocity profiles are uniform throughout the water column from 1 m above the bed (Fig. 6). Vertical velocity profile measurements were conducted in the channel thalweg. A similar homogeneous trend was demonstrated by nearly all the measurements at the two different channel locations and during the different times (Fig. 3). In addition, overall flow velocity and trends through the channel thalweg, measured in January 2001 shortly after the dredging and in August-November 2002 after significant accumulation on the north shoal, are similar. The similarity indicates that the flow through the channel thalweg along the south side of Blind Pass is not significantly influenced by either the dredging or the shoaling that mainly occur along the north side.

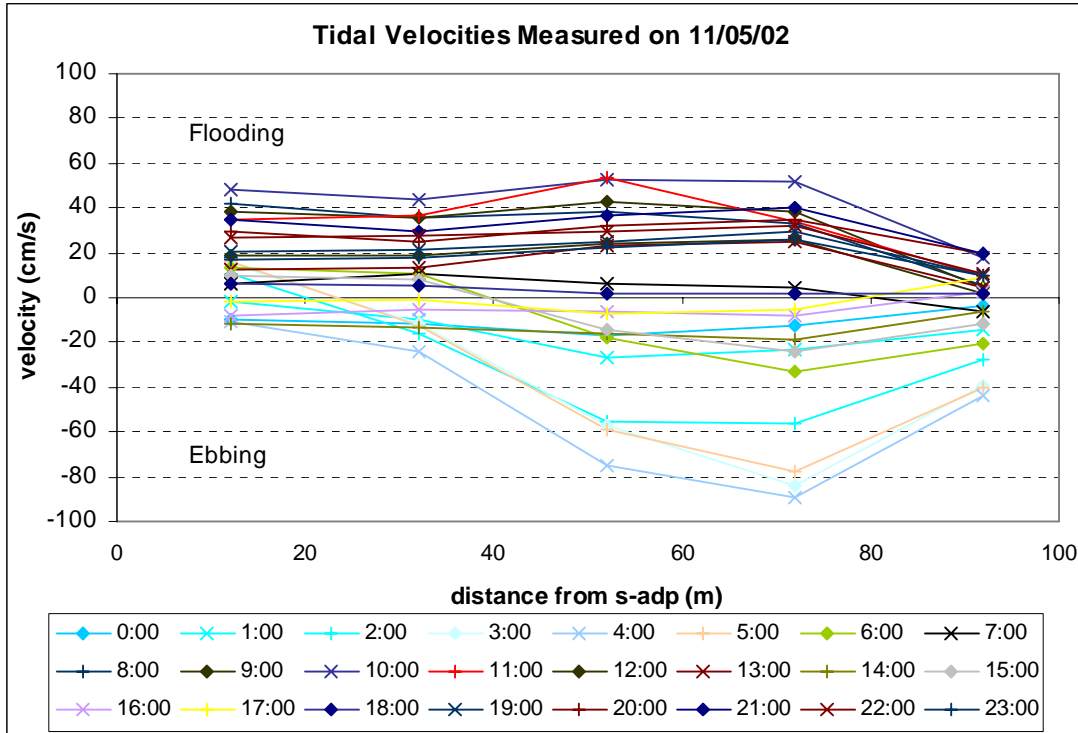
Fig. 7. Example of typical tidal flow distributions across the channel during spring tide.

In contrast to the homogeneous vertical velocity profiles, tidal flow velocity exhibits substantial horizontal spatial variation across Blind Pass channel. In addition, the cross-channel distribution pattern differs between ebb tide and flood tide (Fig. 7). During ebbing tide, flow velocity measured at the channel thalweg is 3 to 4 times greater than that measured over the north shoal. The peak ebb velocity through the channel thalweg approaches 1 m/s, the equilibrium velocity documented at many inlets (Bruun 1978). During flooding tide, flow velocity is primarily uniform across the channel, peaking at

about 0.5 m/s. This distribution of tidal flow velocity across the inlet channel can be attributed to the nearly 90-deg bend. The northern side of the inlet lies in the shadow zone of the ebb current as it turns around the corner. Such a sharp bend is common for migratory inlets, resulting from extension of the updrift barrier island and recession of the downdrift barrier. Therefore, the tidal flow distribution shown in Fig. 7 is likely not unique to the Blind Pass entrance channel.

The predicted horizontal tidal flow patterns across the inlet channel also compare well with the measured pattern (Figs. 7 and 8). The ebb flow tends to hug the south side over the channel thalweg with a peak flow of approximately 1 m/s, whereas flow over the north shoal is much weaker (Fig. 8A). The flood flow tends to be uniform across the channel, peaking at about 0.5 m/s (Fig. 8B). This cross-channel flow pattern is closely related to the shoaling pattern, discussed in the next section.

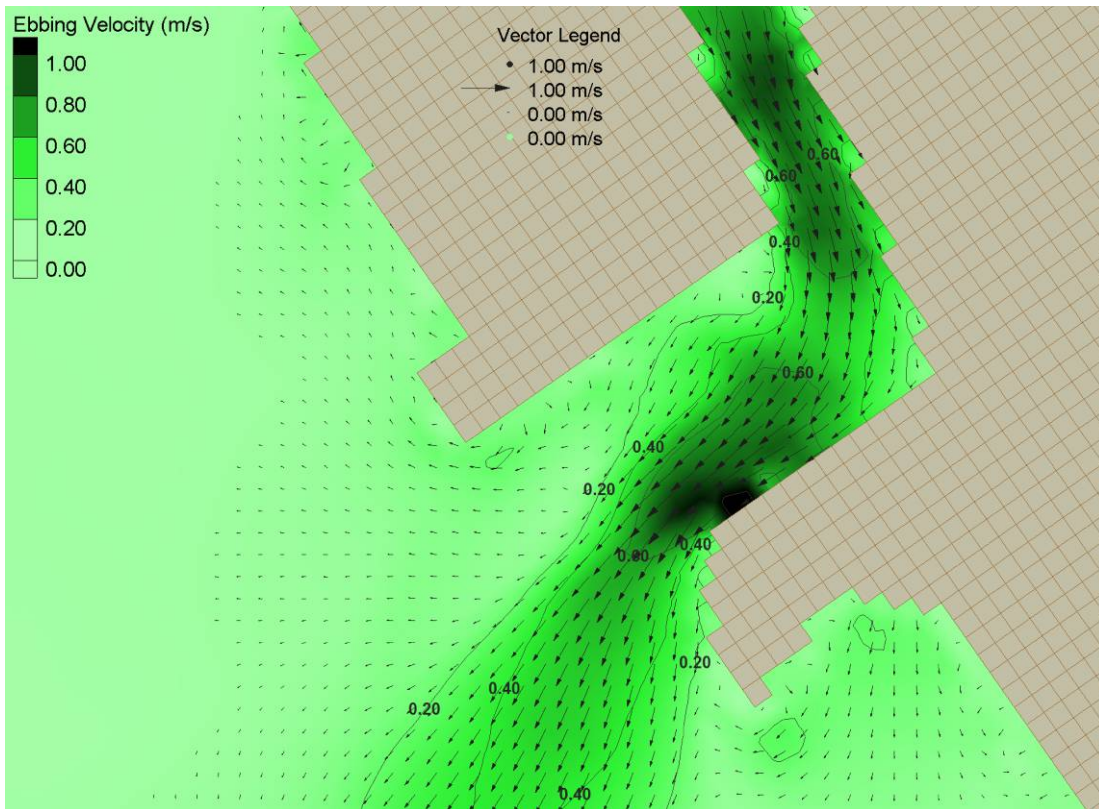
Fig. 8. Examples of modeled ebb (upper panel) and flood (lower panel) flow patterns through Blind Pass.

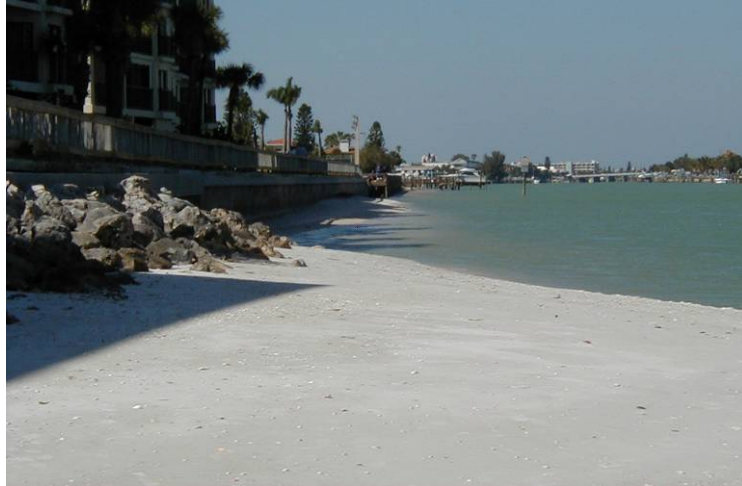
Fig. 10. Beach development along the back side of Treasure Island at Blind Pass, looking north.

From August 2002 to August 2003, net sedimentation of 17,000 m³ occurred, as the sum of 25,000 and 2,800 m³ accumulation from August 2002 to December 2002 and from August 2002 to May 2003, respectively, and 11,000 m³ of erosion from May 2003 to August 2003. From August 2003 to June 2004, net accumulation of 26,000 m³ occurred. For both years, net accumulation occurred in the winter months and net erosion in the summer months. This seasonal trend is reflected more clearly in the monthly north-shoal survey, discussed in the following. The reduced amount of sedimentation during 2003 and 2004 is related to sediment backpassing around the corner of the inlet. A beach has developed on the back side of Treasure Island since 2003 and is growing (Fig. 10).

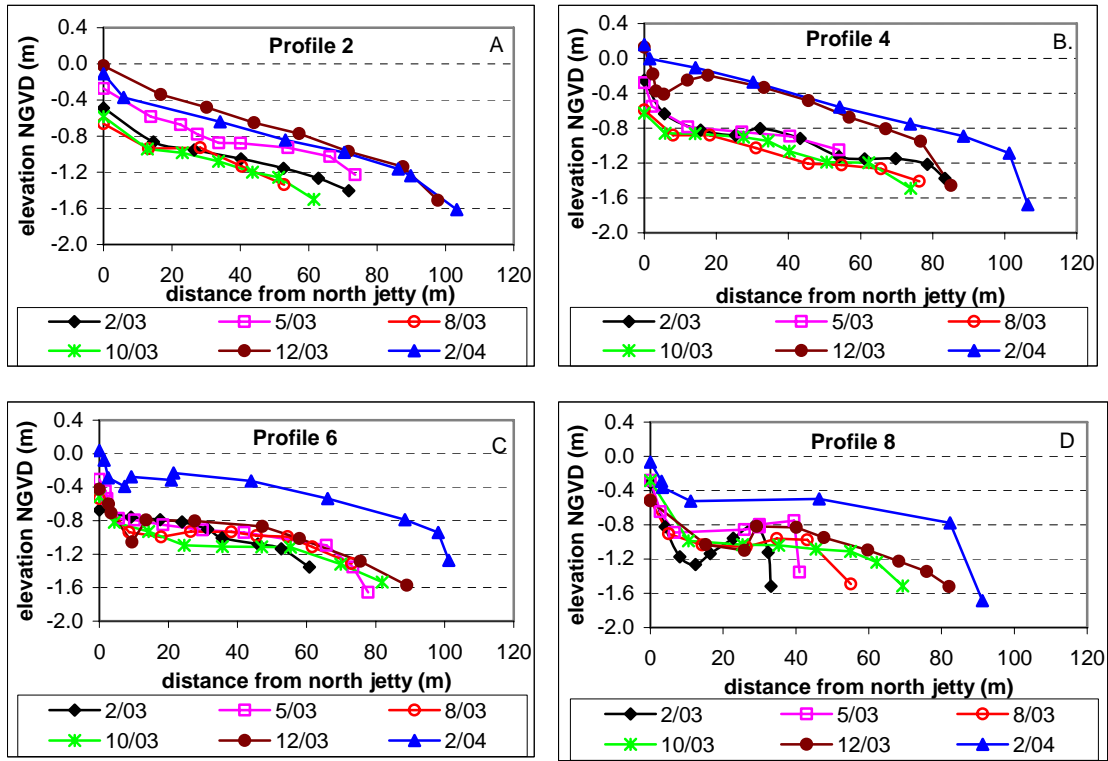
Fig. 11. Time-series of shoaling pattern in Blind Pass entrance channel.

Fig. 11 demonstrates both seasonal and event-driven shoaling and scouring at Blind Pass. During the summer when southwest wind dominates, and little sediment is trapped in the inlet because the sediment supply from the eroding Upham Beach to the south is limited. Furthermore, ebb flushing along the south side is active. As a matter of fact, scour was observed on the north shoal near the inlet entrance, indicating that the sand at the mouth area is being moved further into the inlet, and around the bend. Significant sediment shoaling occurred at the mouth area during the early winter starting in late

October, especially after the passages of the first several cold fronts. The northerly winds and waves are a major mechanism in driving southward longshore sand transport. The longshore moving sand can deposit readily into the space that was created during the summer season at the mouth area. This body of sand migrates further into the inlet during the winter. Therefore, shoaling in the Blind Pass entrance can be summarized as event-driven (particularly by cold fronts) supply of sediment, followed by redistribution during both low- and high-energy conditions.

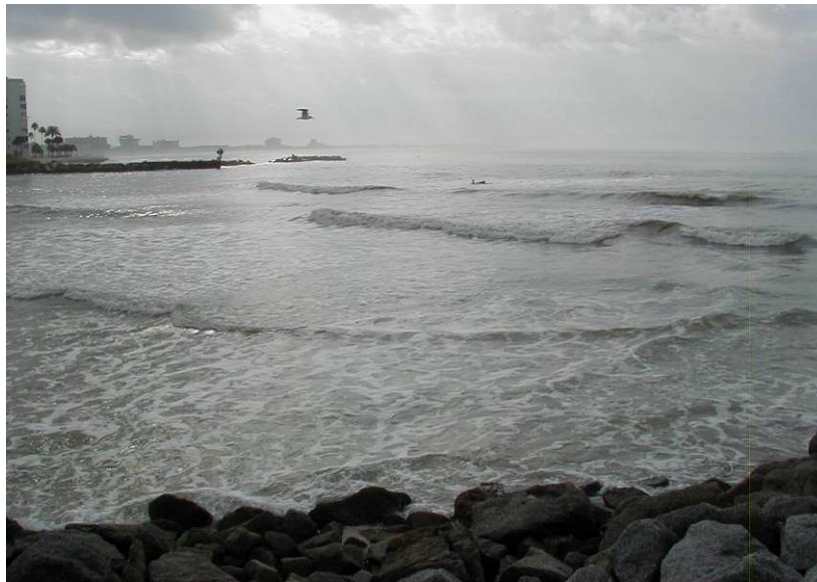
Fig. 11. Wave breaking and surf bores over the north shoal. Looking south.

The relatively strong flood current over the north shoal is a major mechanism transporting sand further into the inlet and around the bend to the back of Treasure Island. This has effectively limited development of an ebb shoal at Blind Pass. In addition to the flood current, wave breaking over the shallow north shoal and the resulting landward moving surf bore should also contribute significantly to landward sand transport, especially during high waves (Fig. 11). The development and significant growth of the beach on the back side of Treasure Island are results of the landward sand redistribution, in contrast to typical seaward sand transport by ebb flow and development of an ebb shoal.
