## Processes and Patterns of Sedimentation at Blind Pass, Florida

David K. Tidwell† and Ping Wang‡

TIDWELL, D.A. and WANG, P., 2006. Processes and patterns of sedimentation at Blind Pass, Florida. *Journal of Coastal Research*, SI 39 (Proceedings of the 8th International Coastal Symposium), 509 - 514. Itajaí, SC, Brazil, ISSN 0749-0208.

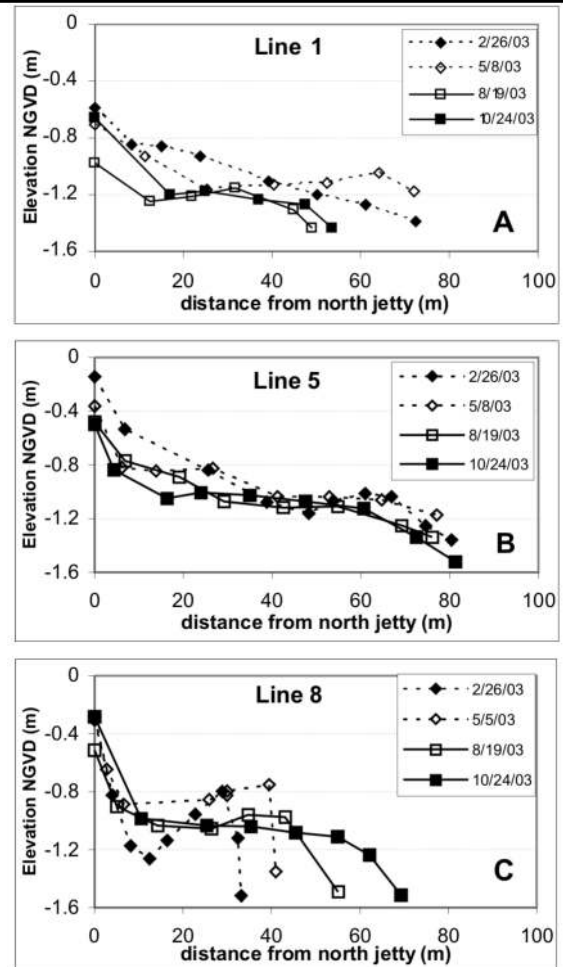
Figure 6. Patterns of sediment accumulation and erosion over the northern shoal. Locations of the lines are plotted in Figure 2.

Our preliminary data indicate that sediment accumulation and erosion patterns over the shallow northern shoal reflect the above seasonal variations of wave condition. At line 1 near the Gulf entrance, erosion was measured during the summer time as compared to the situations in the winter (Figure 6A). The elevations were lower and the extension of the platform was shorter in the summer than in the winter. Similar trend was measured at lines 2 and 3. In the middle of the shoal, including lines 4, 5, and 6, little change was measured from February to October (Figure 6B). Substantial accumulations were measured at lines 7, 8, and 9 toward the landward end of the shoal (Figure 6C). The shoal extended southward toward the main ebb channel for nearly 40 m from February to October. Very steep slope of nearly 28 degrees was measured at the south side

extending into the main channel in the winter. This slope is almost identical to the angle of repose. This steep slope is probably maintained by the strong tidal current around the bent of the channel. The slope along the south side was much gentler in the summer time, although still quite steep. The reason for this change of slope in the winter and summer seasons is not clear. The erosion of the sand accumulation at the bent (Figure 5B) may have contributed to the slope change. Continued profile surveys and offshore wave measurements are being conducted to further quantify these seasonal changes.

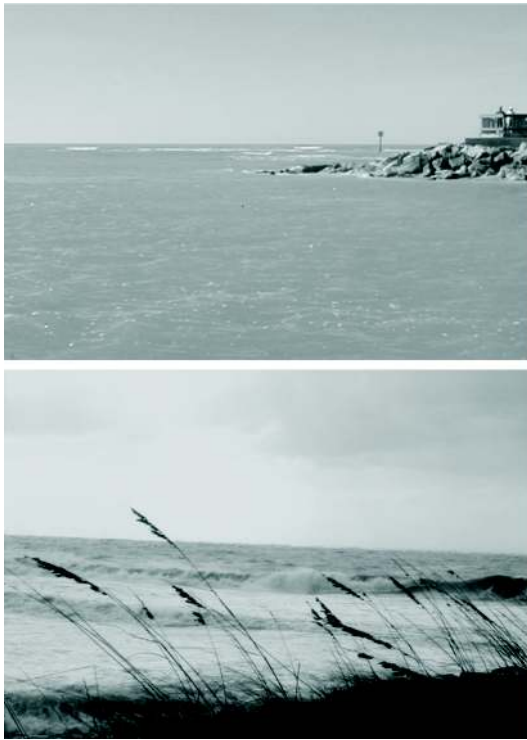
Figure 7. Active wave breaking over the northern shoal in the inlet channel. Upper: wave breaking during low tide; lower: wave breaking during a winter storm.

shallow. Substantial wave breaking occurs during low tide and during storm conditions (Figure 7). During February 2002, a considerable portion of the shoal became exposed during spring low tide. The active sediment suspension due to wave breaking at low tide and the relatively strong flood current over the northern shoal area (Figure 4A) may provide a mechanism for landward sediment transport. This mechanism is believed to be responsible for the erosion near the Gulf entrance and accumulation further in the channel measured during the summer season.
